GEOTECHNICAL AND SALINITY INVESTIGATION REPORT

ADDRESS: 146 Regent Street, Riverstone, NSW

DATE: 7 February 2018

REPORT NO: NE236

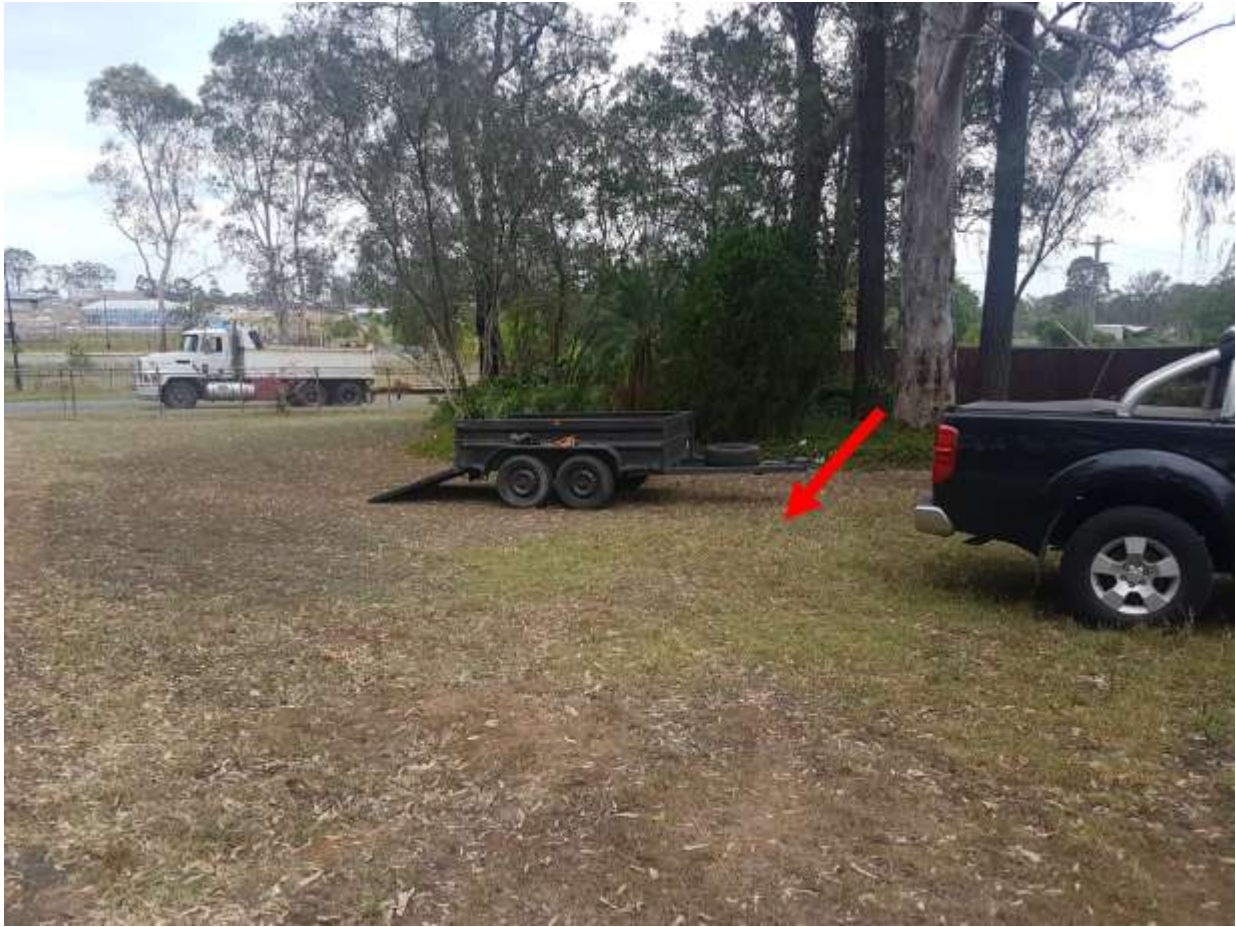
Location of borehole BH1

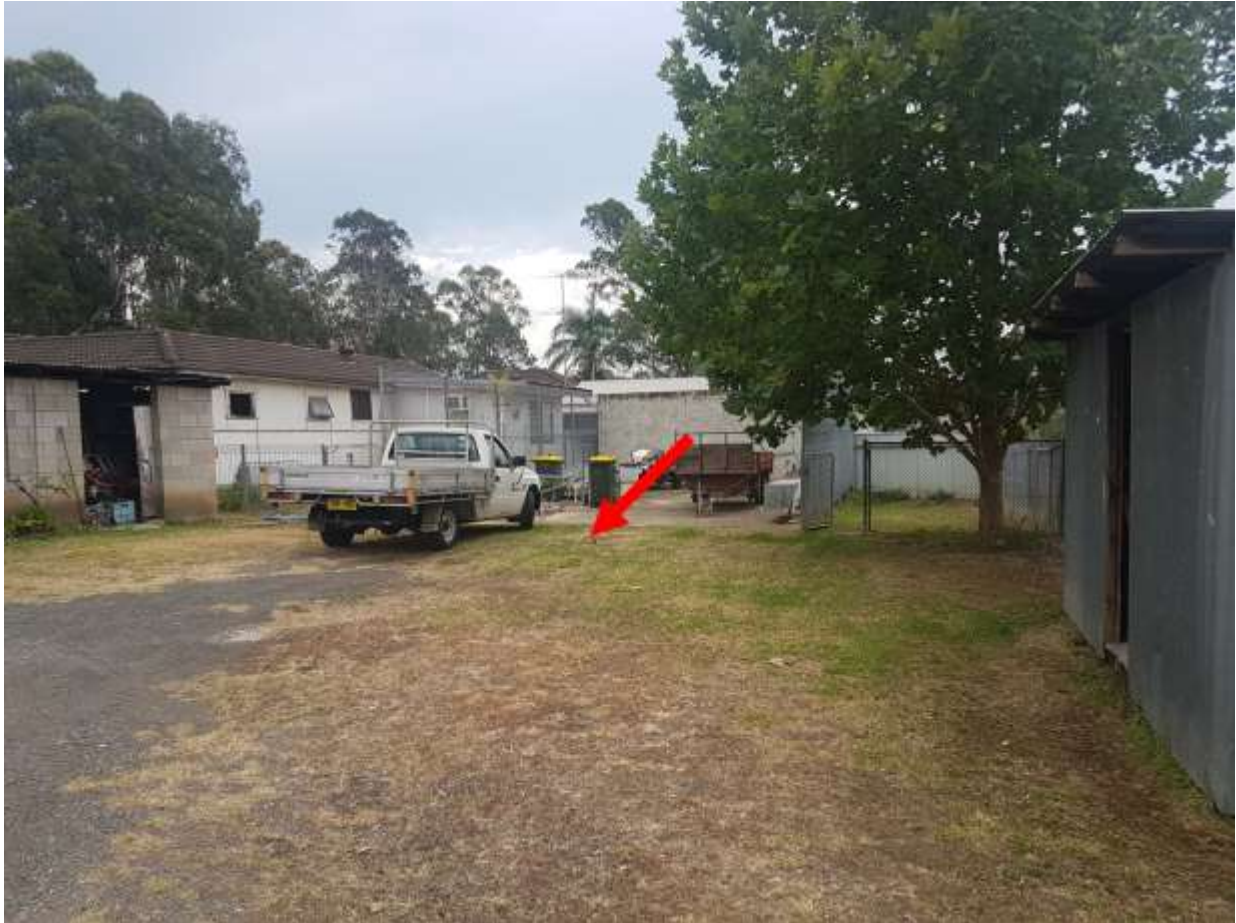
Location of borehole BH2

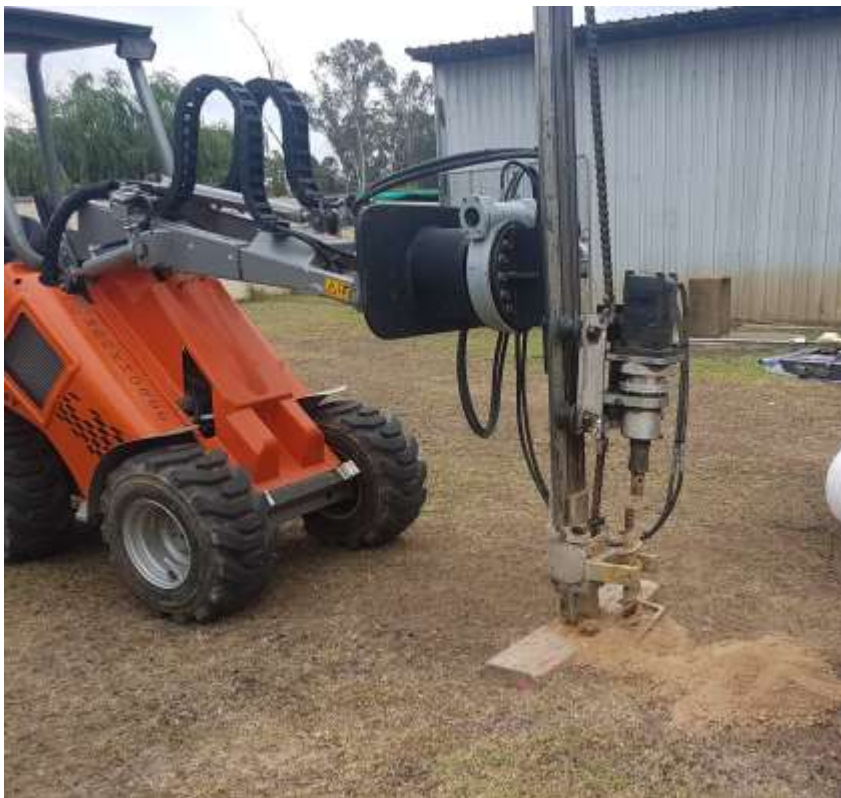
Location of borehole BH3
