PRELIMINARY CONTAMINATION ASSESSMENT

**LOT 2 IN DP260476
RICHMOND ROAD, MARSDEN PARK**

REPORT NO 13552/1-AA 30 MAY 2016

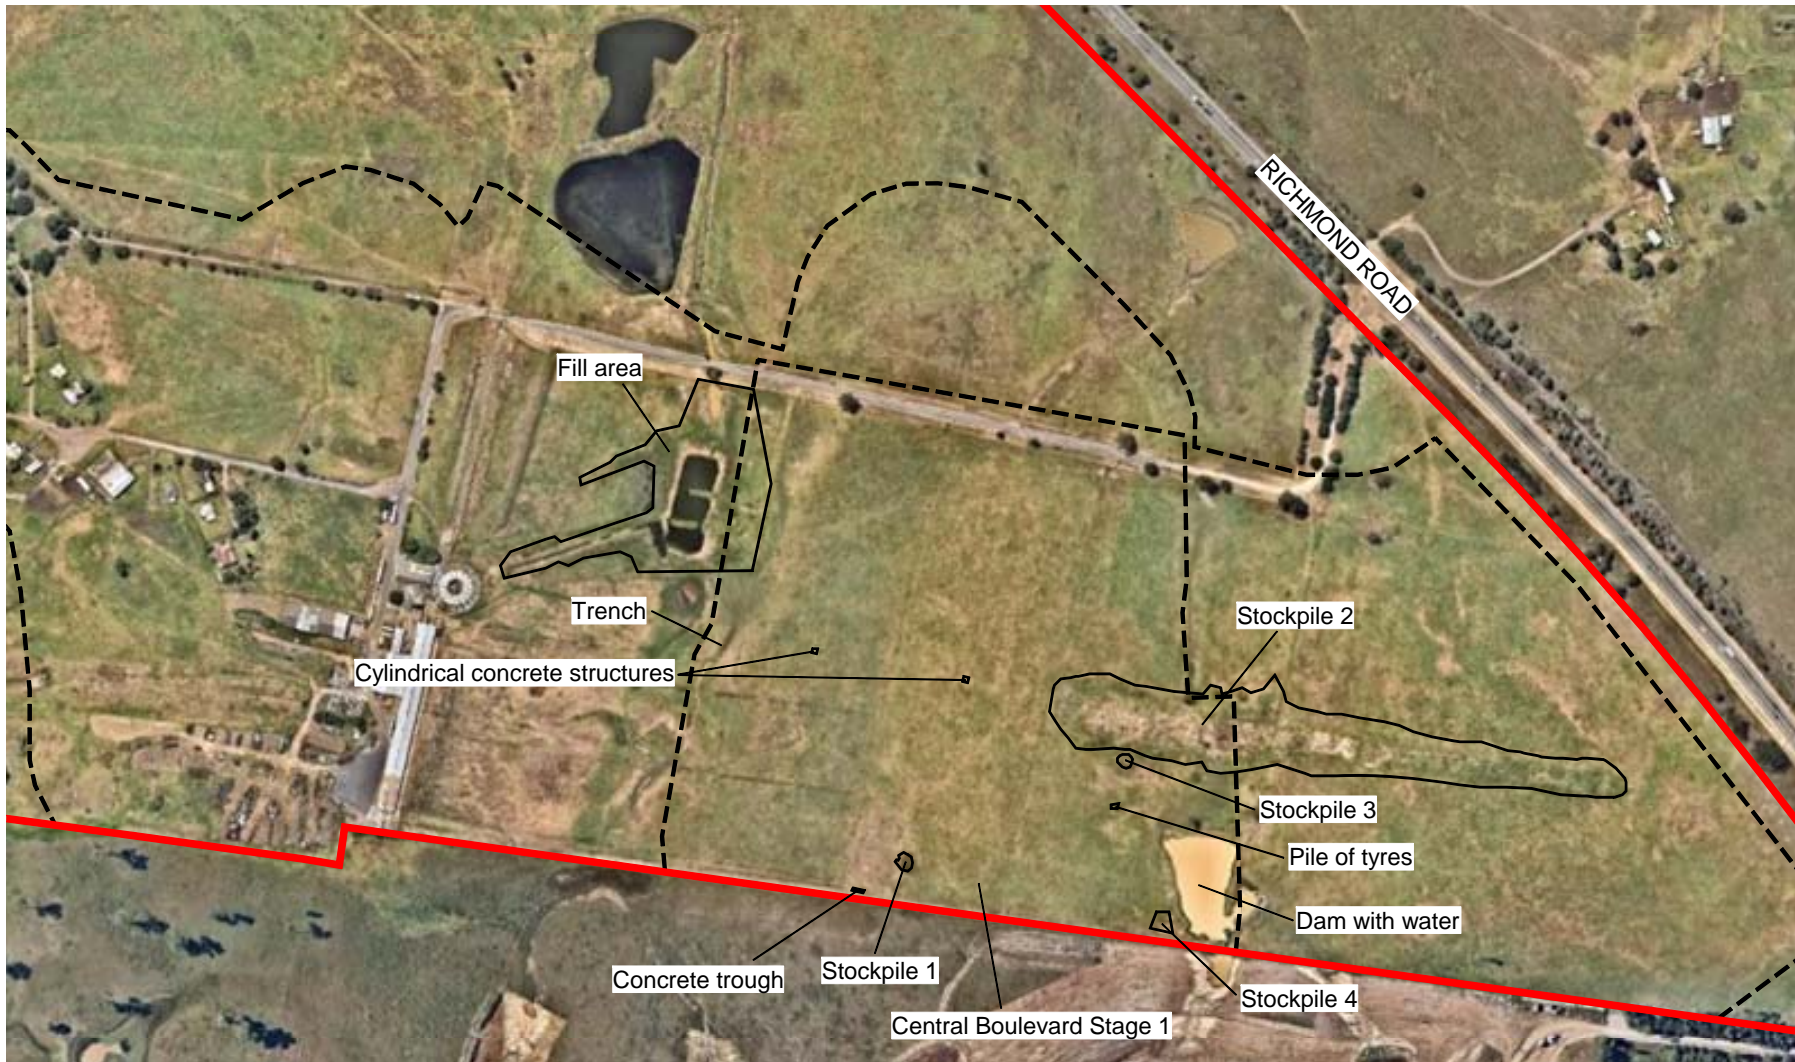
Drawing No: 13552/1-AA1
Job No: 13552/1
Drawn By: MH
Date: 12 April 2016
Checked By: SS/DS

<i>Drawing No 13552/1-AA1</i>	<i>Site Features (Central Boulevard Stage 1 Development)</i>
<i>Drawing No 13552/1-AA2</i>	<i>Test Pit Locations (Central Boulevard Stage 1 Development)</i>
<i>Drawing No 13552/1-AB1</i>	<i>Site Features (excluding Central Boulevard Stage 1 Development)</i>
<i>Drawing No 13552/1-AB2</i>	<i>Test Pit Locations (excluding Central Boulevard Stage 1 Development)</i>
<i>Drawing No 13552/1-AC1</i>	<i>Locations of Concern</i>

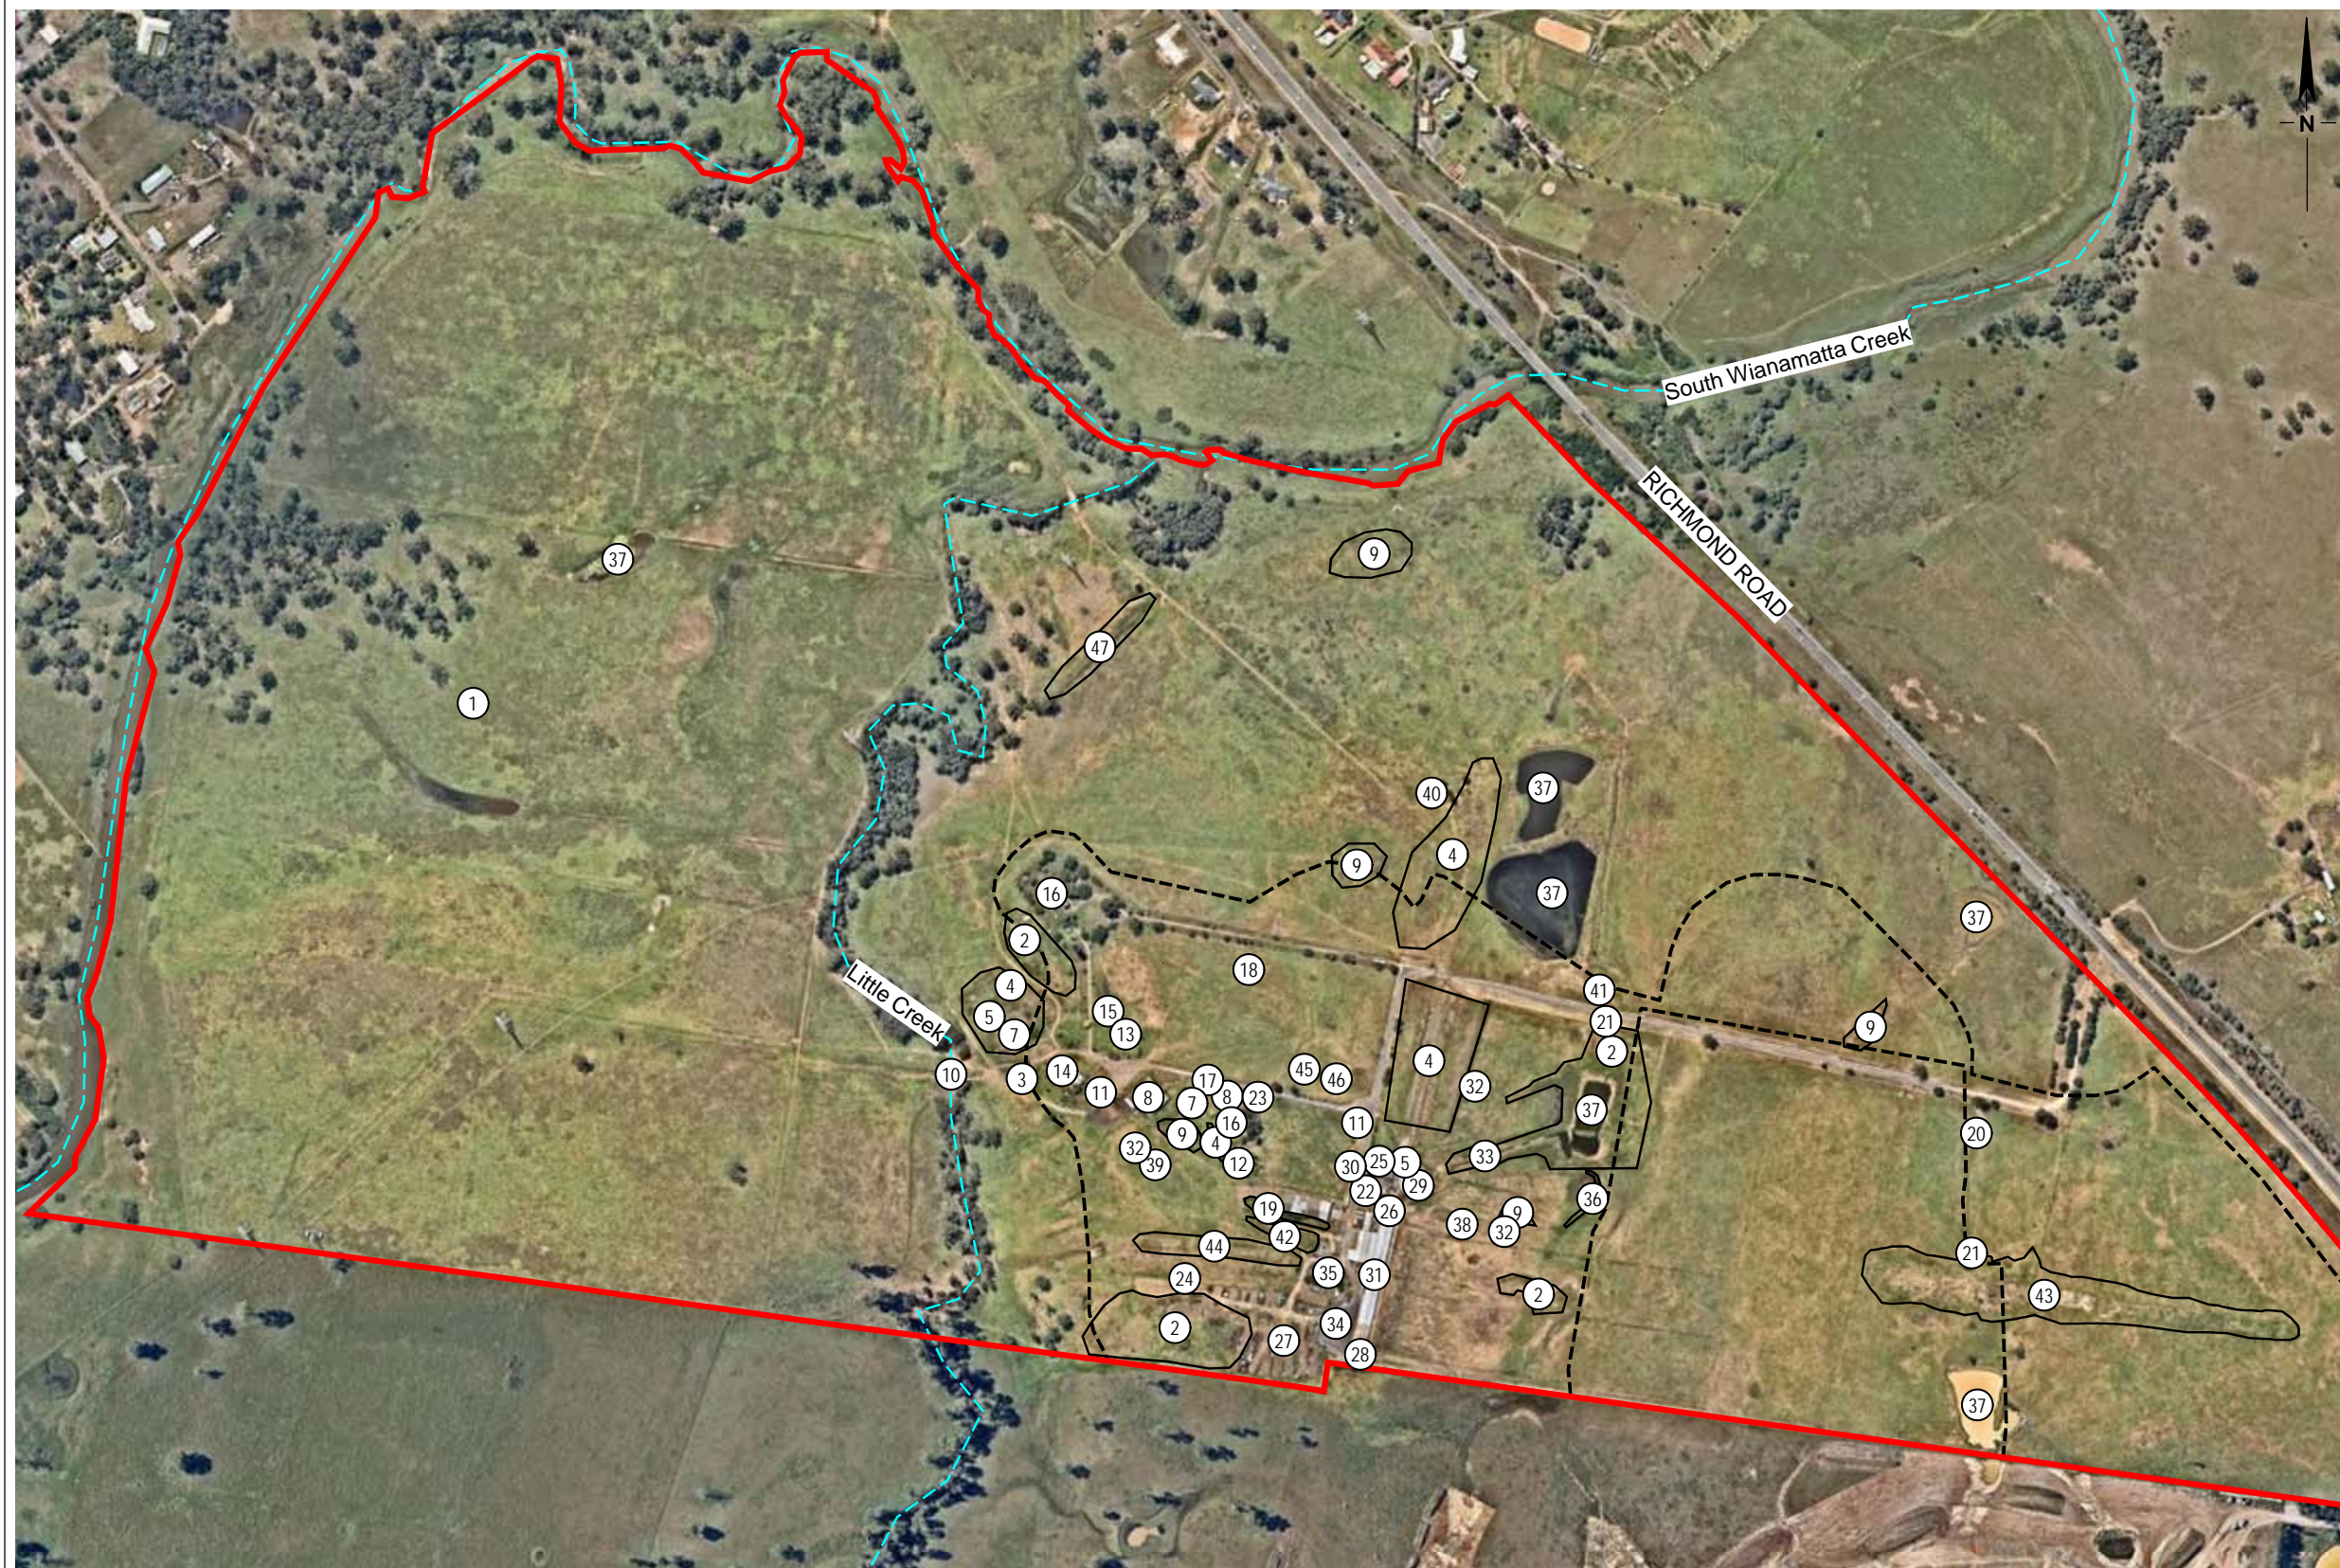
Drawing No: 13552/1-AB1
Job No: 13552/1
Drawn By: MH
Date: 13 April 2016
Checked By: SS/DS

SF#	Description
1	Flat, open paddocks
2	Fill area
3	Open metal shed
4	Fill/stockpile area
5	Shipping container
6	Wooden pieces, tyres, and scrap metal
7	Fibro-cement, weatherboard and timber house, with metal roof
8	Metal shed
9	Possible fill area
10	Bridge crossing
11	Truck trailers
12	Fibro-cement house with tile roof
13	Weatherboard and fibro-cement house, with metal roof
14	Brick building with metal roof
15	Weatherboard house with metal roof
16	Weatherboard and brick house, with metal roof
17	Fibro-cement and metal house, with tile roof
18	Scattered metals and concrete on paddock
19	Rubber tubing and scrap metal
20	Trench
21	Concrete pipe
22	Building structure with tile roof
23	Damaged car
24	Bitumen observed on ground
25	Scrap metal and wooden pallets
26	Plastic containers
27	Metal trusses, corrugated sheets, wooden pallets, containers, scrap metals and timber
28	Wooden pallets and scrap metal
29	Dairy carousel
30	Fill area with concrete slab and underground tank

31	Corrugated metal shed
32	Concrete trough
33	Deep trench
34	Unsealed driveway
35	Concrete storage area
36	Earth mound
37	Dam with water
38	Metal trough
39	Graveyard
40	Metal Structure
41	Trench with water
42	Tyres
43	Stockpile 2
44	Stockpile 7
45	Stockpile 8
46	Stockpile 9
47	Stockpile 10
