ARBORICULTURAL IMPACT ASSESSMENT REPORT

REGENT STREET RESERVE, RIVERSTONE

DOC No: ARB-2220-001

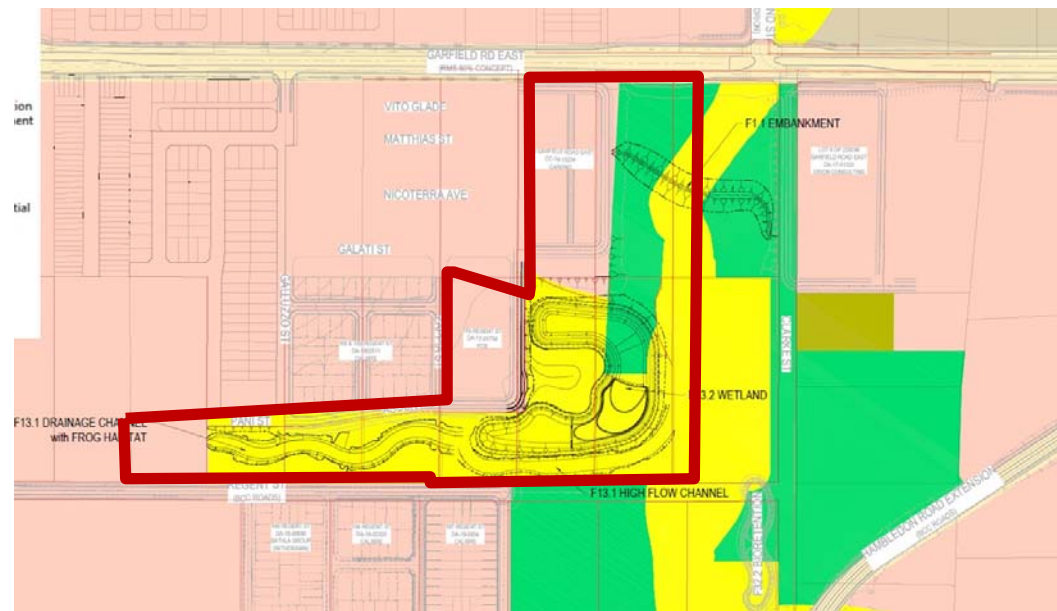
Sturt Noble Arboriculture was engaged by Blacktown Council to prepare an Arboricultural Impact Assessment Report and Tree Protection Recommendations in relation to the proposed wetland, embankment and channel works associated with the CP20 Regent Street Basin and Reserve 917 project. The extent of works is shown in the red ringed zone below:

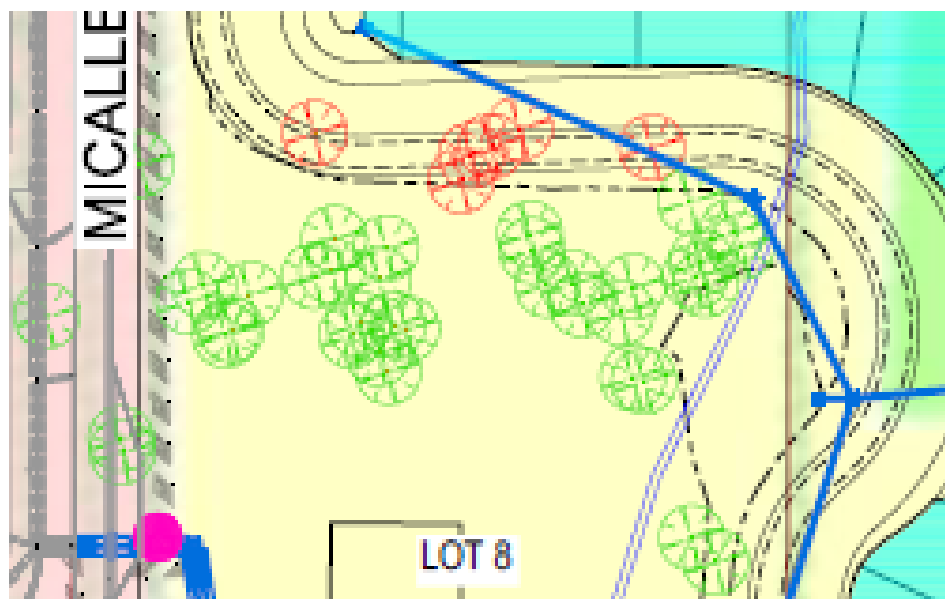
36 trees surrounded by the new wetland are potentially enabled to be retained (trees shown in green below).

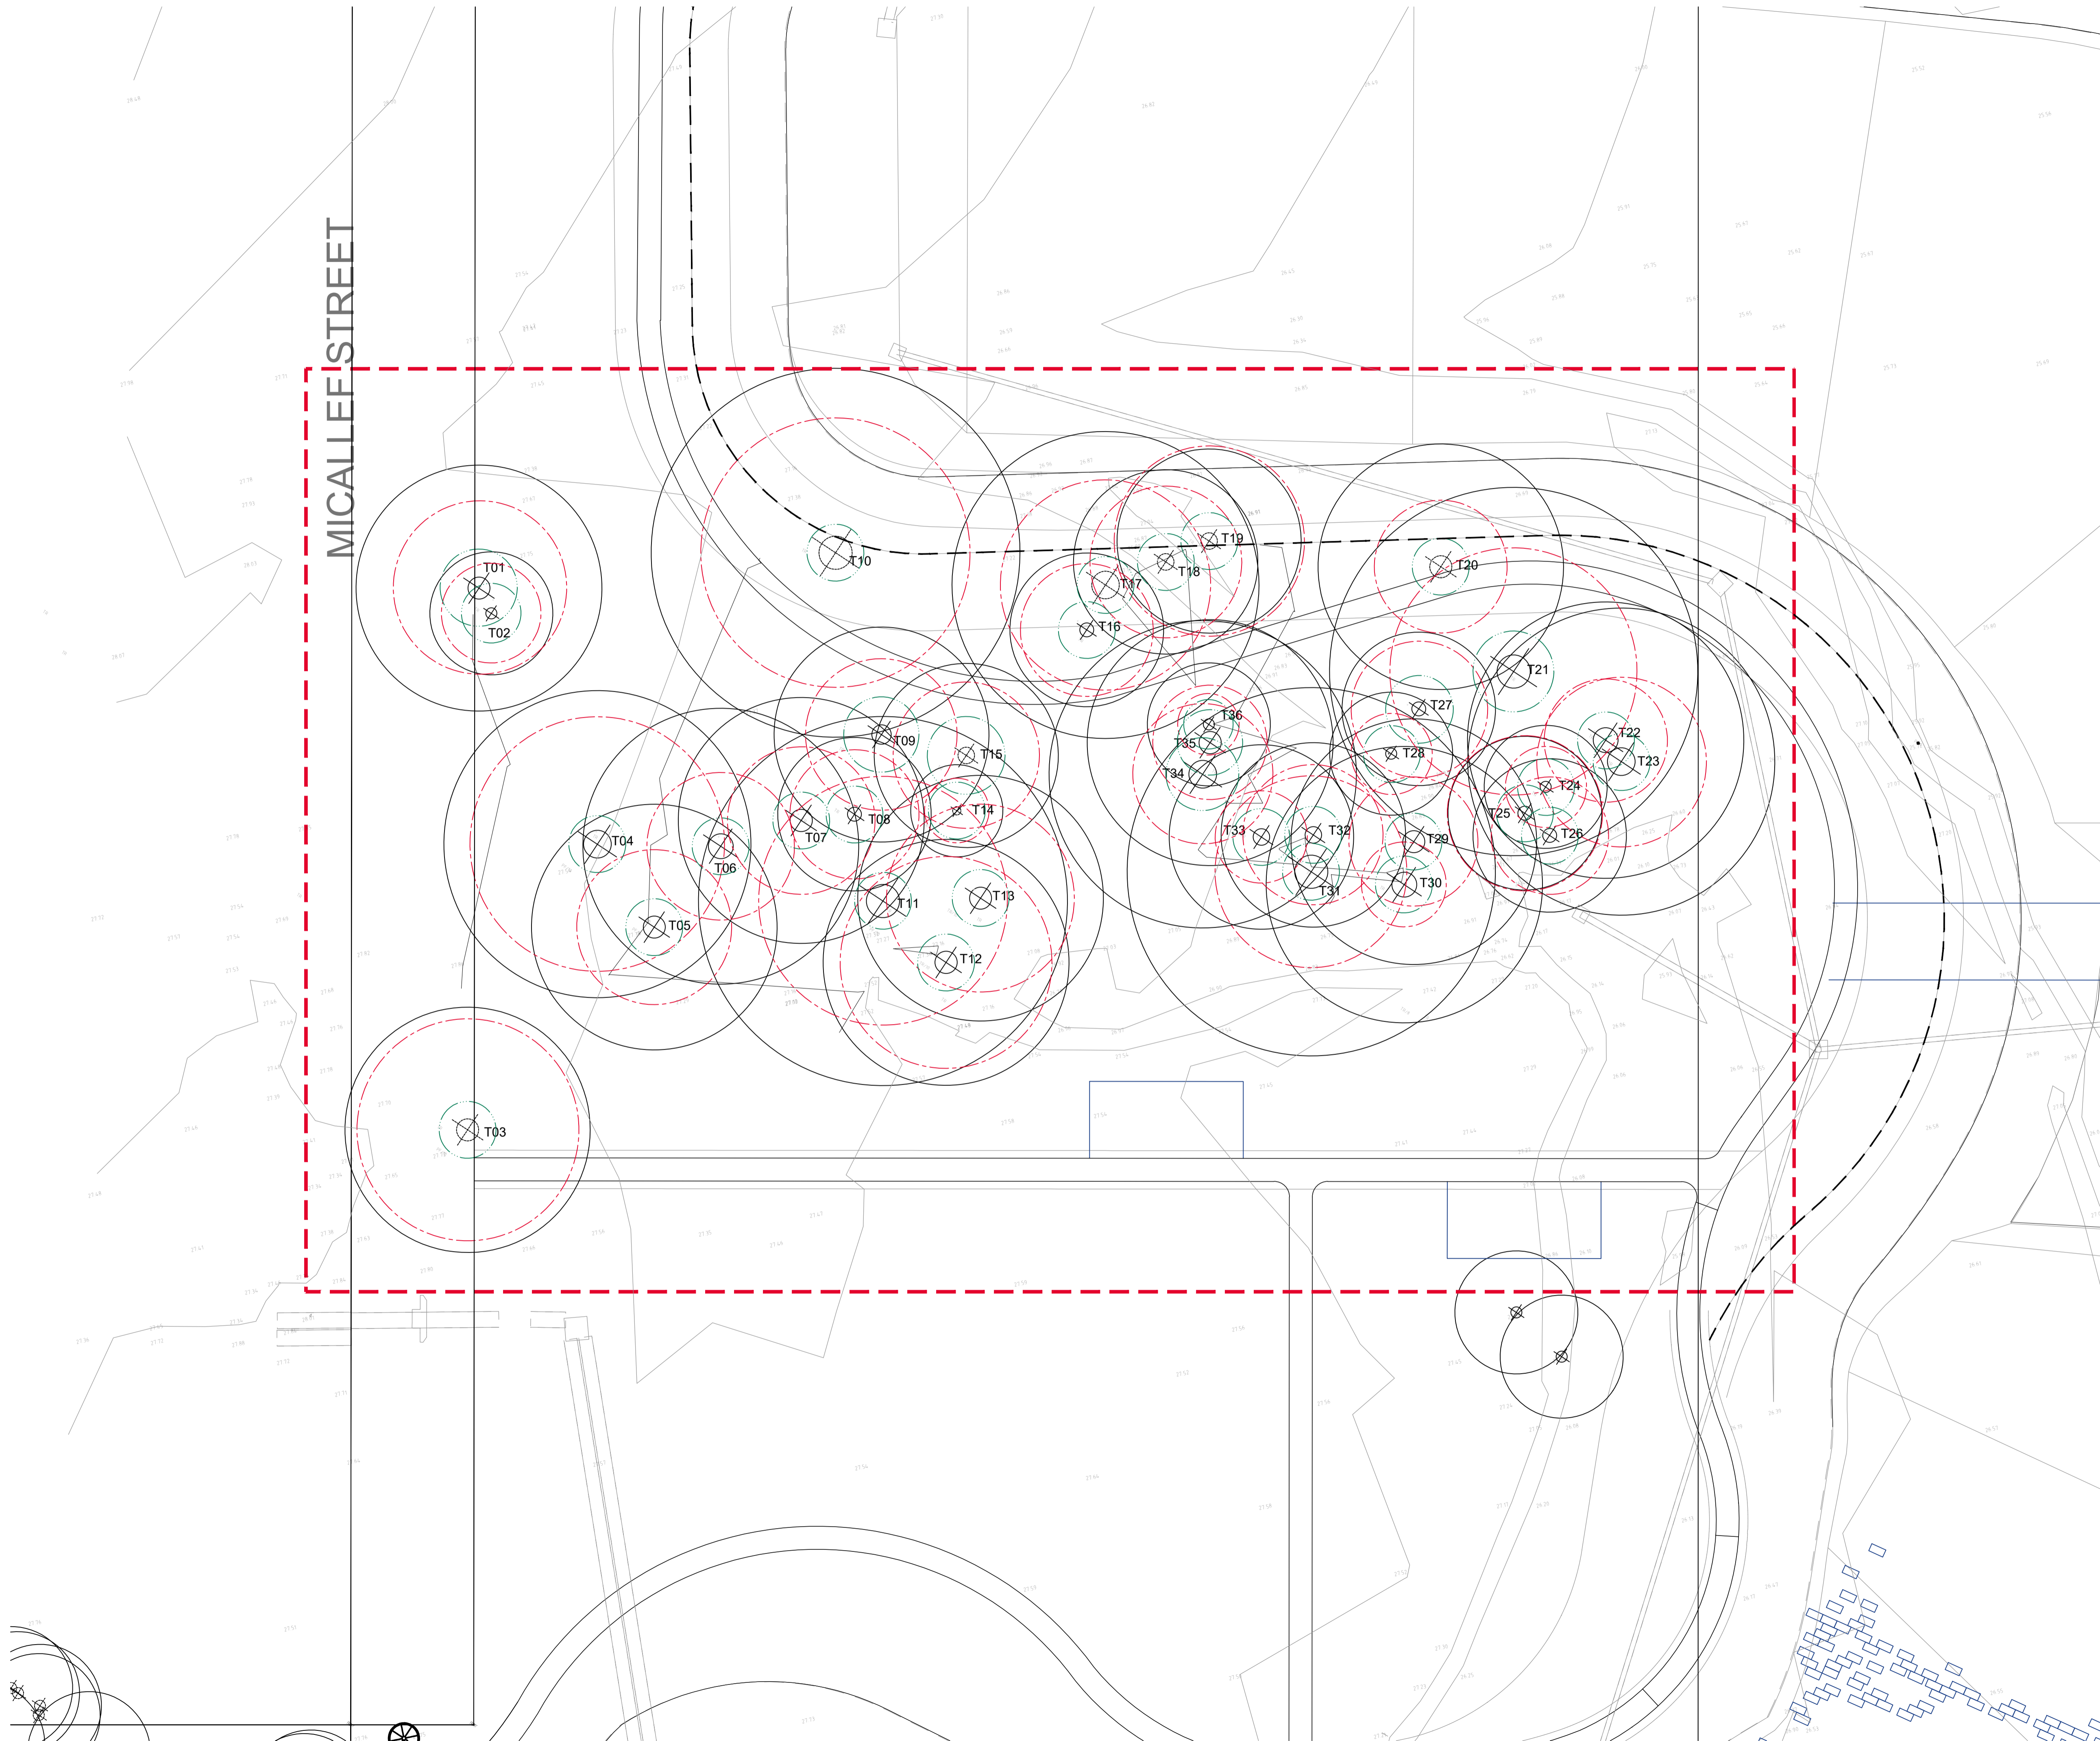
- LEGEND**
- EXTENT OF WORKS
 - EXISTING SURVEY
 - EXISTING TREE. TREE NUMBERS RELATE TO ASSESSED TREES
 - STRUCTURAL ROOT ZONE (SRZ)
 - TREE PROTECTION ZONE (TPZ)
 - EXTENT OF DISTURBANCE

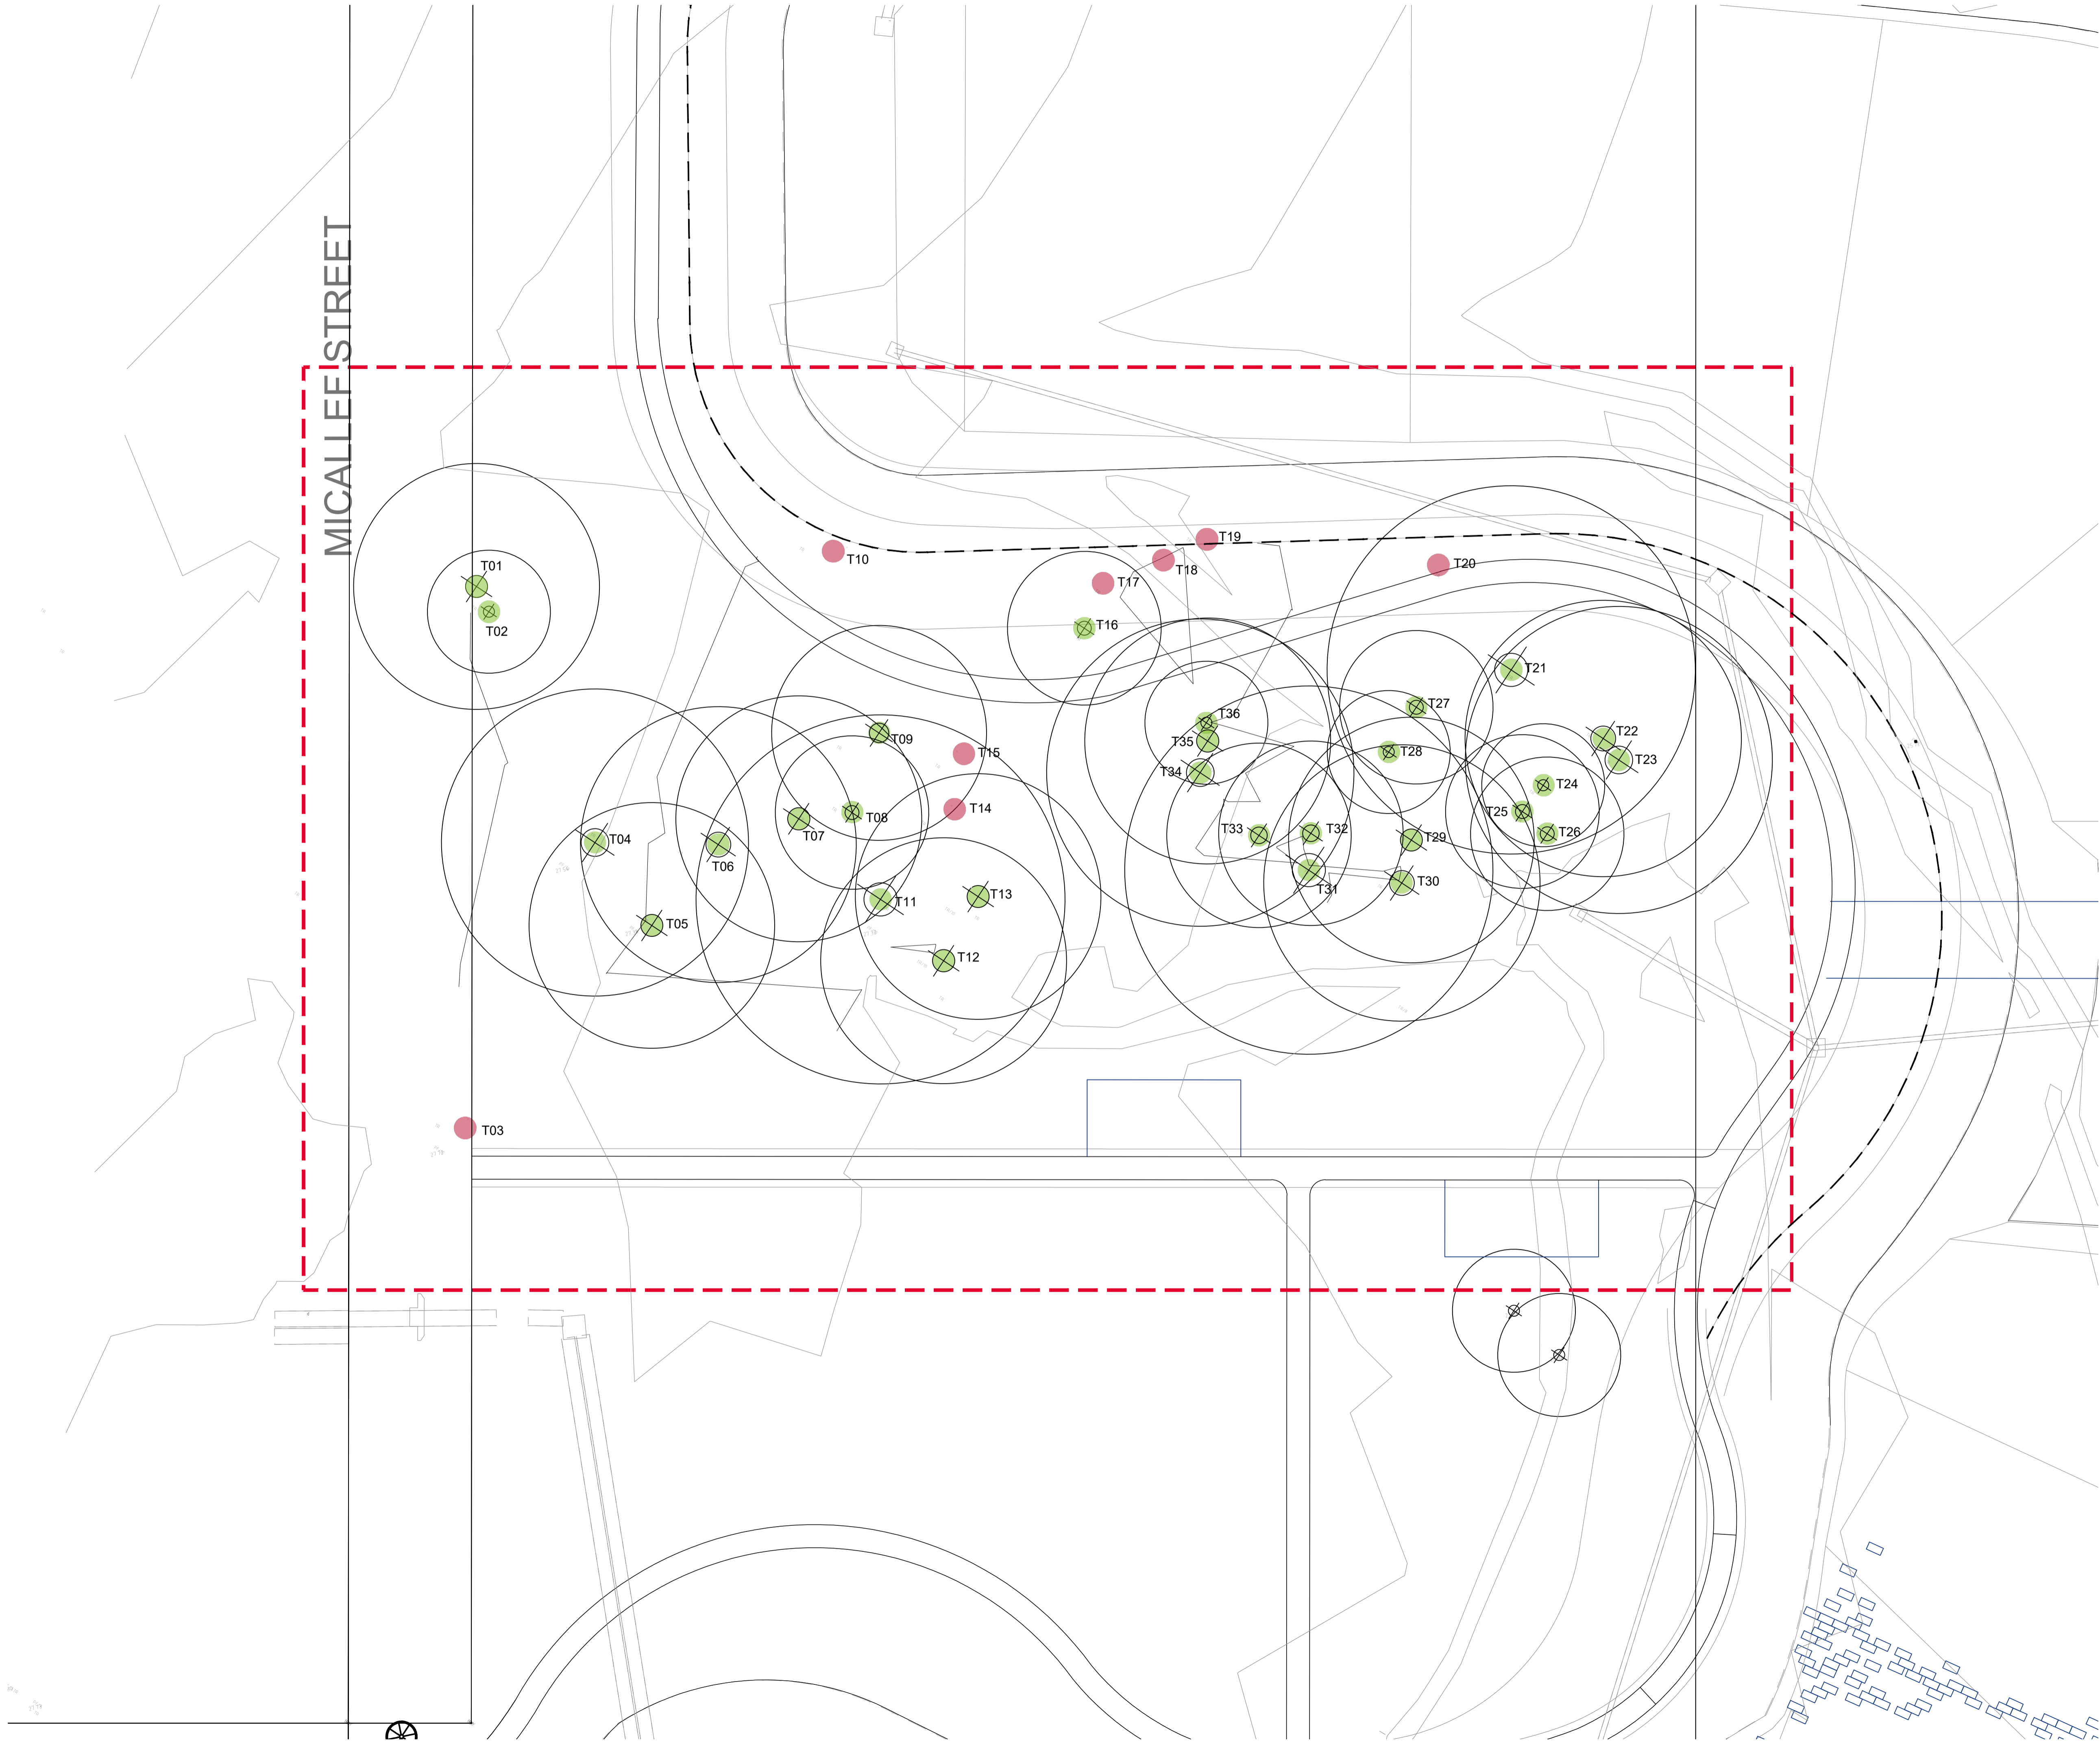
- LEGEND**
- EXTENT OF WORKS
 - EXISTING SURVEY
 - EXISTING TREE. TREE NUMBERS RELATE TO ASSESSED TREES
 - STRUCTURAL ROOT ZONE (SRZ)
 - TREE PROTECTION ZONE (TPZ)
 - TREES TO BE RETAINED
 - TREES TO BE REMOVED

- Eight (8) trees will need to be removed to accommodate the proposed works. These trees are Nos. 3, 10, 14, 15, 17, 18, 19, 20. Refer to the tree encroachment and retention plan in **Appendix 2**.
- Twenty-eight (28) trees are to be retained as part of the proposed development. These trees are Nos. 1, 2, 4 – 9, 11 – 13, 16 and 21 – 36. Trees to be retained as part of the approved works must be protected from potential damage caused by construction activities. Refer to section 5.0 for tree protection recommendations and to the tree encroachment and retention plan in **Appendix 2**.
- Tree no. 21 has an encroachment greater than 10% to its TPZ. It is proposed non-invasive exploratory trenching (Refer 5.10 Root investigation) is carried out as indicated on the plan.

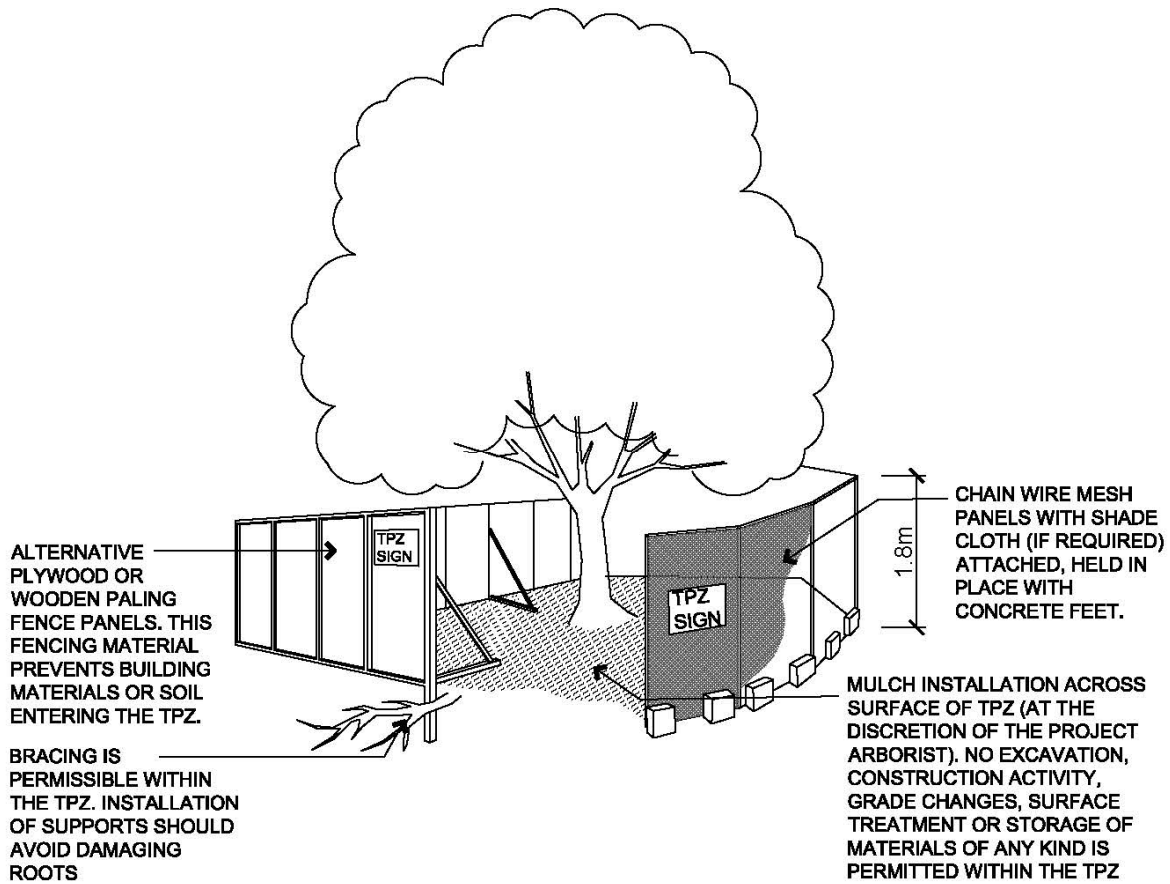
PROTECTIVE FENCING

Based on AS4970-2009

As a minimum the fence should consist of temporary chain wire panels 1.8 metres in height, supported by steel stakes as required and fastened together and supported to prevent sideways movement. The fence shall be erected prior to the commencement of any work on-site and shall be maintained in good condition for the duration of construction. Where tree protection zones merge a single fence encompassing the area is deemed to be adequate.

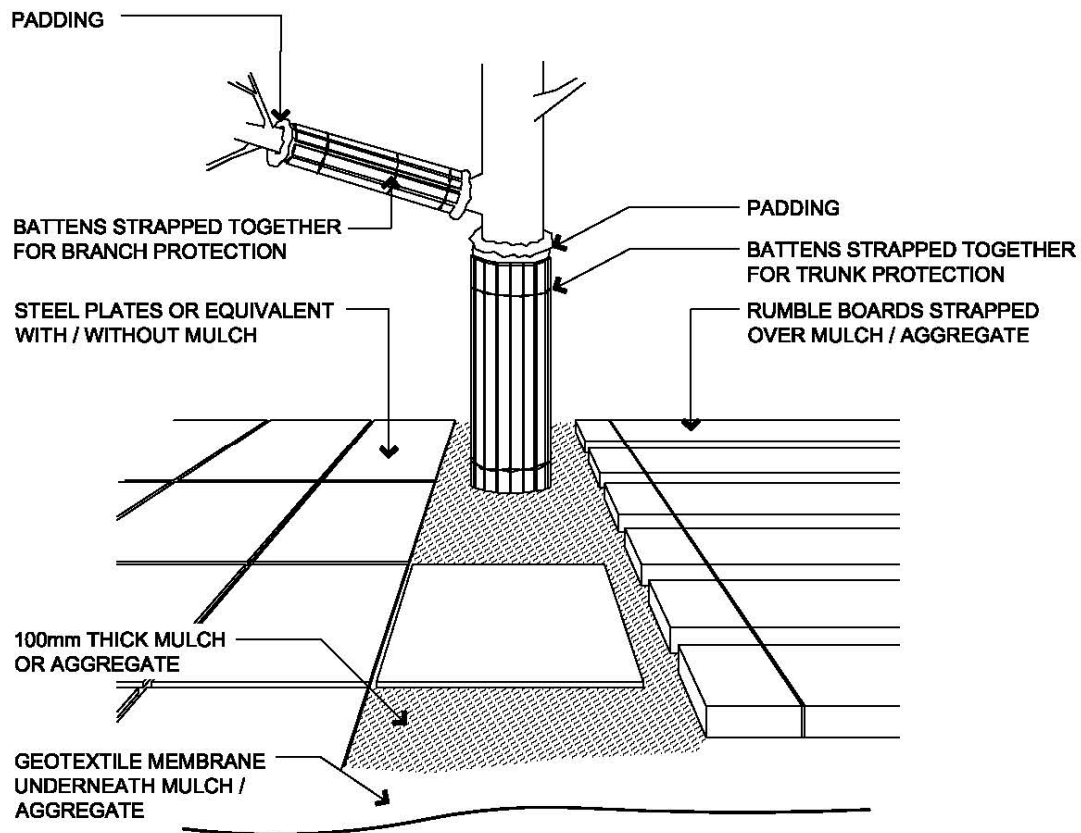
1. For trunk and branch protection use boards and padding that will prevent damage to bark. Boards are to be strapped to trees, not nailed or screwed.
2. Rumble boards should be of a suitable thickness to prevent soil compaction and root damage.

Where provision of tree protection fencing is impractical due to its proximity to the proposed building envelope, trunk protection shall be erected around the tree to avoid accidental damage. As a minimum, the trunk protection shall consist of two metre (2m) lengths of hardwood timbers (100 x 50mm) spaced at 100-150mm centres secured together with 2mm galvanised wire. These shall be strapped around the trunk (not fixed in any way) to avoid mechanical injury or damage. Trunk protection should be installed prior to any site works and maintained in good condition for the duration of the construction period.

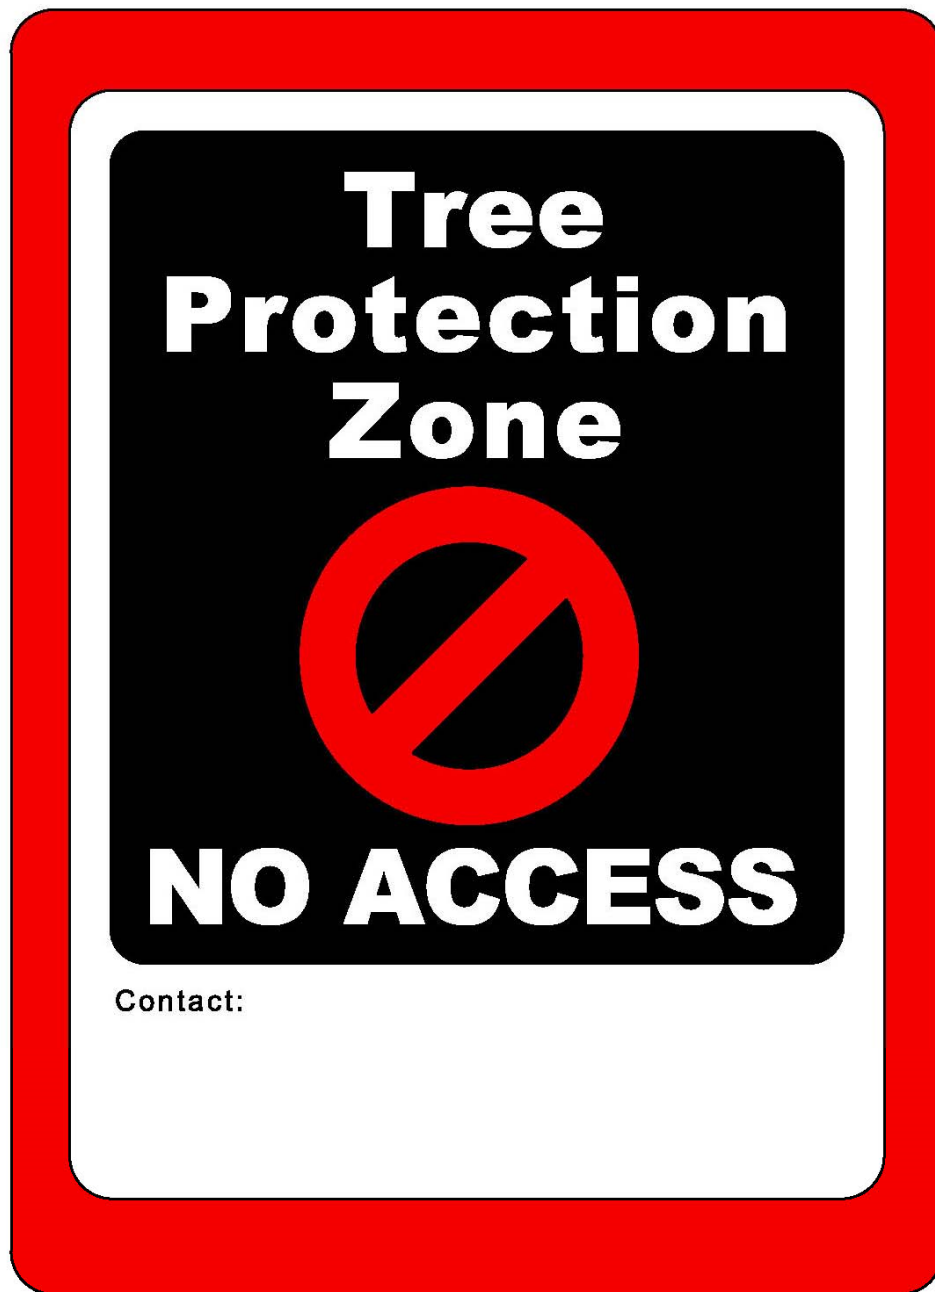
TREE PROTECTION ZONE SIGN

Based on AS4970-2009
